National Highway Traffic Safety Administration

Case Vehicle (A): 1999 Mercury Type: Villager 4 x 2, 4-door wagon

Veh. (B): 1995 Ford

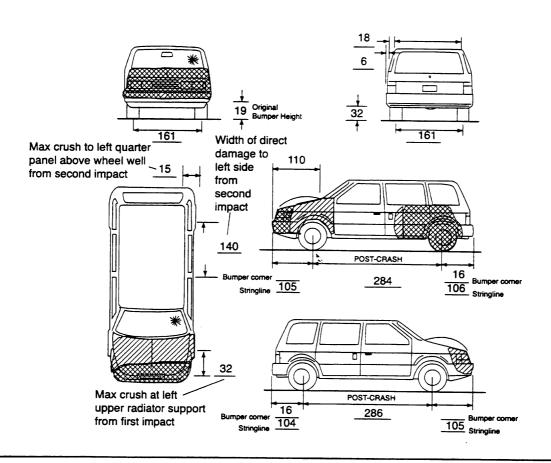
VEHICLE DAMAGE

(Slide 3) Overall damage to case vehicle (A) was moderate. (Slide 4) Direct damage to case vehicle (A) from the first impact extended across the entire frontal plane and overrode the front bumper. (Slide 5) The maximum crush was 32 cm at the left center of the upper radiator support. (Slide 6) Left-side damage to case vehicle (A) from the second impact began 51-cm forward of the left-rear bumper corner and extended 140-cm toward the front. The maximum crush from the second impact was 15 cm, at a point just forward of the left-rear wheel.

Crush profiles were measured for case vehicle (A) (slides 7, 8, 9 and 10) at the level of the bumper and (slides 11, 12, 13 and 14) at the level of the upper radiator support. Using these crush values and the average value at the two levels if the difference was \geq 13 cm, the

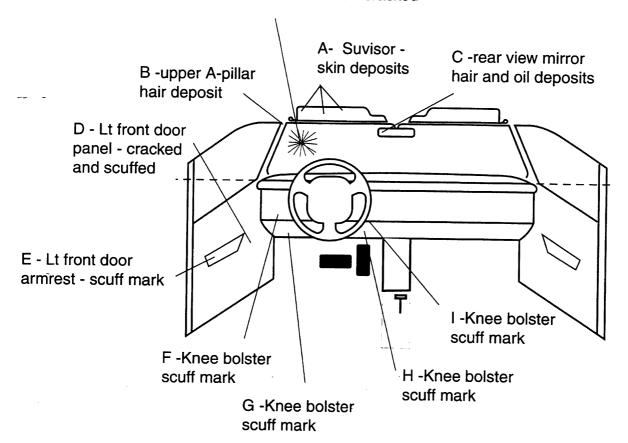
Interior	Occupant	Dodu		Confidence
		Occupant	Body		Level of
	Component	No. if	Region		Contact
Contact	Contacted	Known	if Known	Supporting Physical Evidence	Point
Α	Lt sunvisor	Driver	Face	Skin	1
В	Upper A- pillar	Driver	Lt f arm or face	Short hairs	2
С	Rear-view mirror	Driver	Rt Hand	Short hairs and oil	2
D	Lt front door	Driver	Lt side	Cracked and scuffed	2
E	Lt front door armrest	Driver	Lt side	Scuffed	2
- F	Knee bolster	Driver	Lt knee	Scuffed	1
G	Knee bolster	Driver	Lt knee	Scuffed	1
Н	Knee bolster	Driver	Rt knee	Scuffed	1
1	Knee bolster	Driver	Rt knee	Scuffed	1
J	Windshield	Driver	Lt hand	Cracked	1
K					
L					
М

J - windshield - cracked
